**== USS STUMP (DD-978) ==**  
**SEMAT I SHELL CONDITION ASSESSMENT**  
**SURVEY**  
**INTERIOR AREAS**  
**11/26/01 TO 12/01/01 -- 12/17/01 TO 12/21/01**

Q.E.D. Systems, Inc. was tasked by the Supervisor of Shipbuilding Conversion and Repair, USN (SPORT) Portsmouth, VA to conduct an Ultrasonic Thickness (U/T) Survey of specific locations on board USS STUMP (DD-978) during the period of 26 November 2001 to 01 December 2001 / 17 December 2001 to 21 December 2001.

# USS STUMP (DD-978)

## SHELL CONDITION ASSESSMENT SURVEY INTERIOR AREAS TABLE OF CONTENTS

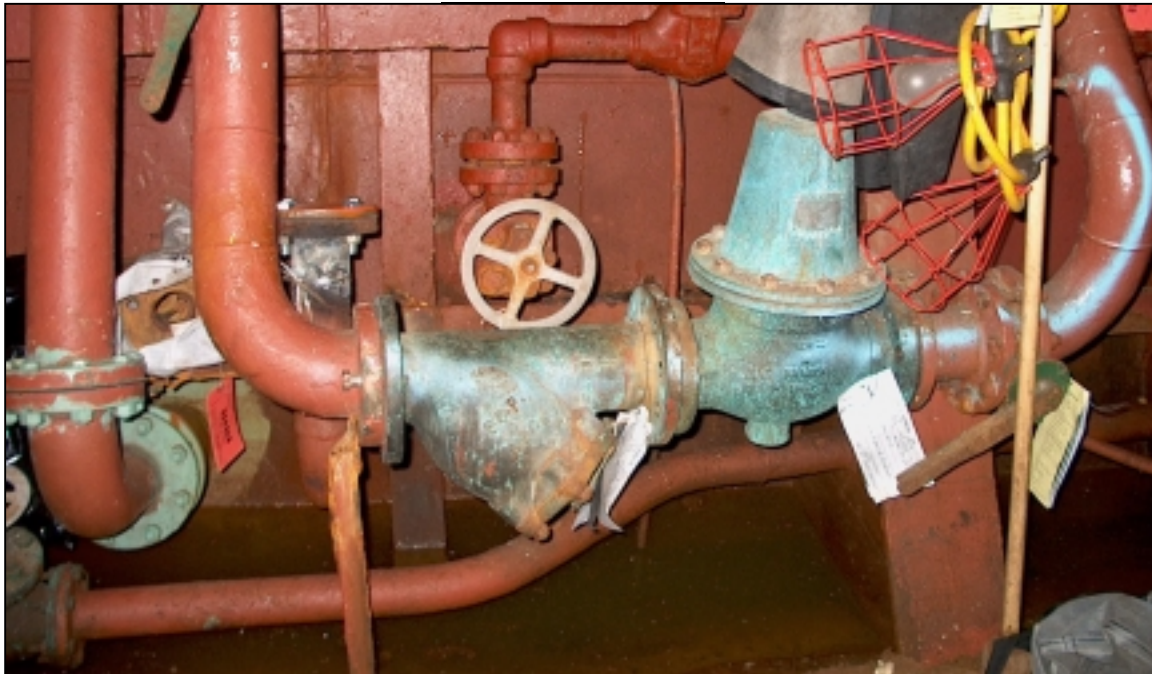
MAN HRS EXPENDED 2	MAN HRS REMAINING 800	COMPLETED ACTION TAKEN		S/F MANHOURS	PRIORITY
SAFETY HAZARD: 1. SERIOUS - CORRECT AS SOON AS POSSIBLE 2. SERIOUS - SUSPENSION OF EQUIPMENT/SYSTEM/SPACE REQUIRED 3. SERIOUS - WAIVER OF EQUIPMENT/SYSTEM 4. SAFETY ITEM - MINOR 5. COMBUSTIBLE MATERIAL		1. MAINTENANCE ACTION COMPLETED: PARTS DRAWN FROM SUPPLY 2. MAINTENANCE ACTION COMPLETED: REQUIRED PARTS NOT DRAWN FROM SUPPLY 3. MAINTENANCE ACTION COMPLETED: NO PARTS REQUIRED 4. CANCELLED - DEFERRAL WILL BE REMOVED FROM CSMP 5. MAINTENANCE ACTION COMPLETED: 3-M CAPABILITY UTILIZED 6. NONE OF THE ABOVE, DESCRIBE IN REMARKS/DESCRIPTION SECTION			1. MANDATORY 2. ESSENTIAL <b>3. HIGHLY DESIRABLE</b> 4. DESIRABLE
DISCREPANCY DESCRIPTION: PER SEMAT I UNDERWATER HULL ASSESSMENT: STBD SIDE (3-426-1-E) NO. 3 GAS TURBINE GENERATOR ROOM					
FIRST STRINGER UP FROM MARGIN PLATE IS HOLED APPROXIMATELY 2 LF FORWARD OF WEB FRAME (434). THE WEB OF

SHELL PLATE AND BILGE POCKET BETWEEN BHD (426)  
AND WEB FRAME (434)

2 <sup>ND</sup> VERTICAL (5 X 4 T-BEAM) AFT OF BHD (426) IS HOLED WHERE IT MEETS FIRST STRINGER. SHELL PLATE IS SEVERELY					
THINNED ON FIRST STRINGER FORWARD OF WEB FRAME (434)					
RECOMMENDED REPAIRS:					
RECOMMEND REPAIR ACTIVITY REMOVE APPROX 8 LF OF FIRST STRINGER REPLACE WITH (10 X 4 X 8.93#) CUT OUT AND REPLACE APPROX					
4 LF OF (5 X 4 X 5.75# T-BEAM) CUT OUT AND REPLACE APPROX 6 SF OF .438 SHELL PLATE. PERFORM NON-DESTRUCTIVE TEST ON					
WELDS. PRIME AND PAINT AREAS DISTURBED BY REMOVALS					
SSPORT C221 POC: J. BRUCKNER (757) 396-4001 EXT 2130, TPOC: J. LaROCK QED SYSTEMS INC. (757) 490-5047					
CSMP SUMMARY: STRINGER / STIFFENER HOLED, SHELL THINNING.				TEST# MRC 1102/1	
ROOT CAUSE/AMPLIFICATION: H1				STEP# 1,2,3,4 & 5	
SYSTEM LEVEL IMPACT:					
PART NO.	NOMENCLATURE		QTY	NSN	COST
1					
2					
3					
4					
5					
6					
FIRST CONTACT TOMS	RATE MR2	SECOND CONTACT BEARDEN	RATE HT2	PHONE

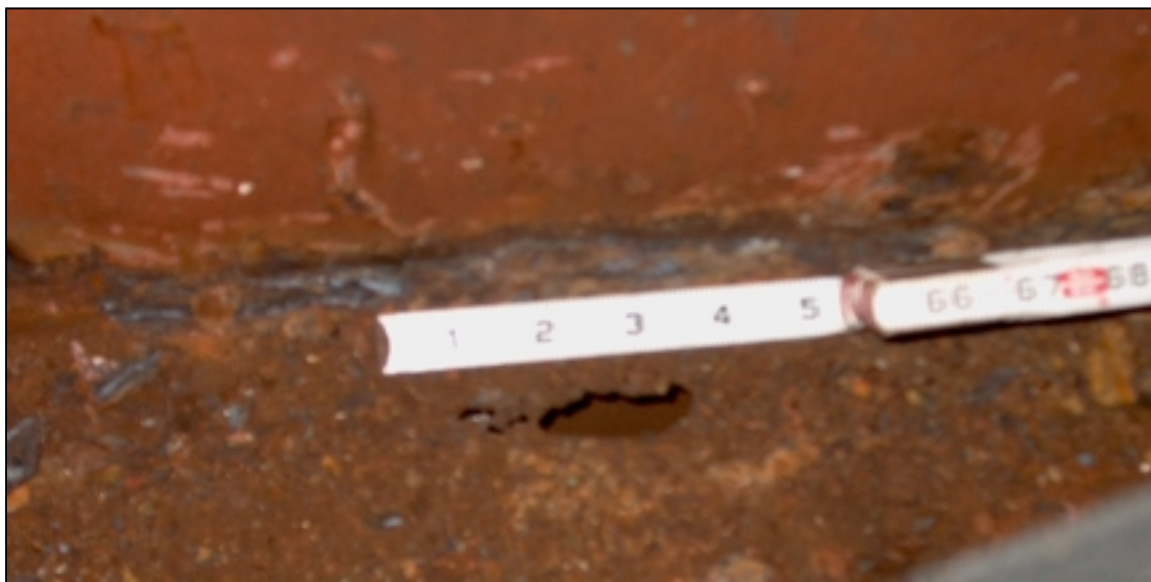
HOLE IN WEB OF FIRST STRINGER UP FROM MARGIN PLATE APPROXIMATELY  
2 FT FORWARD OF WEB FRAME (434)

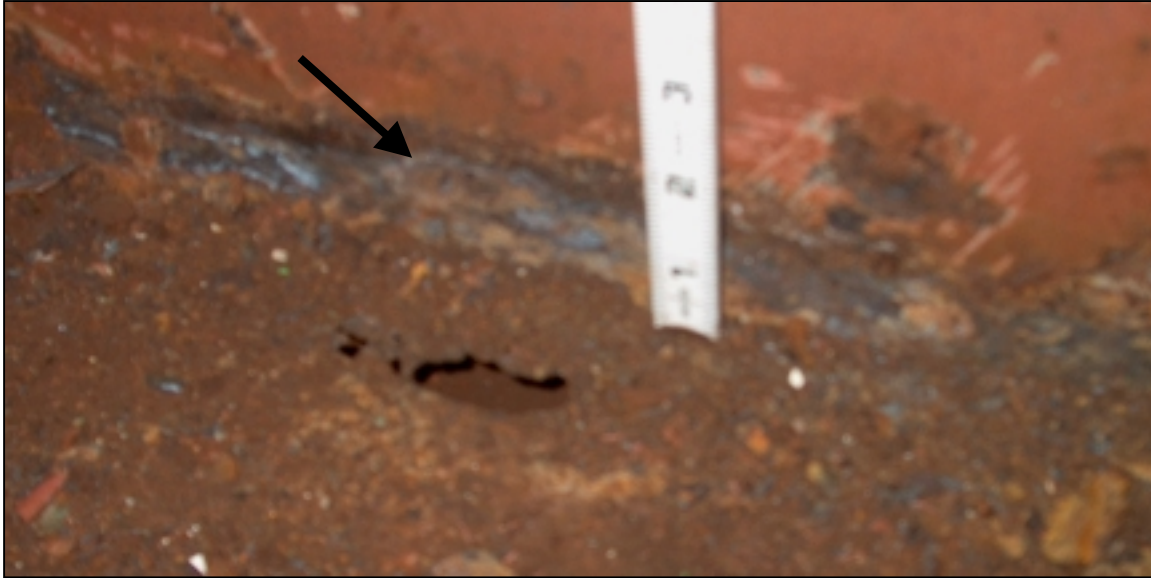
ARROW INDICATES DEEP WASHOUT OF WELD FORWARD OF WEB FRAME (434)  
U/T READINGS ARE BELOW THE 25% WASTAGE ALLOWANCE SEE DRAWING.

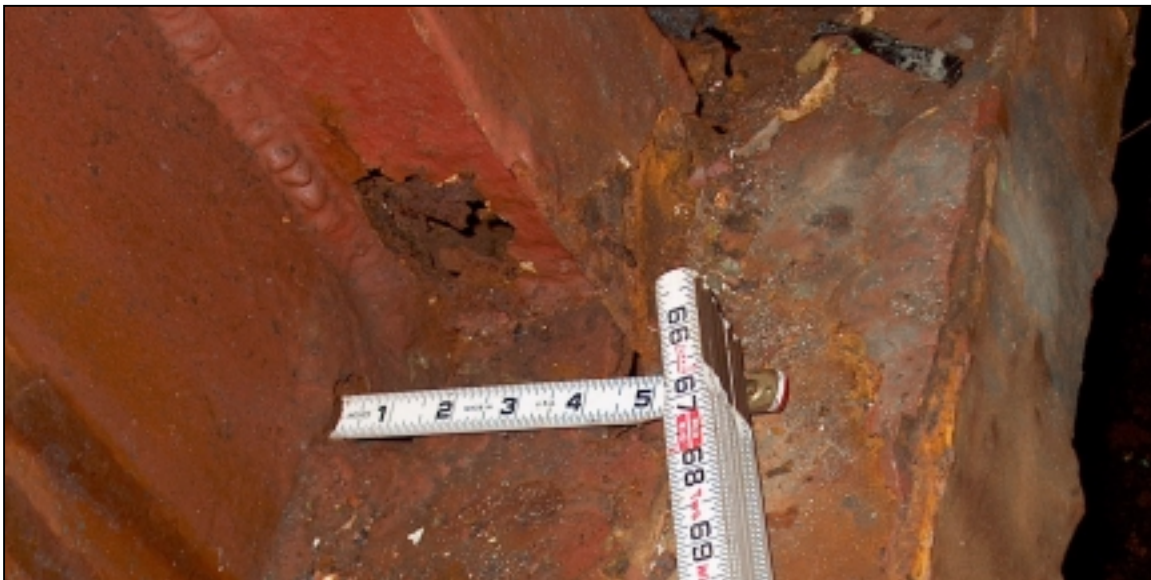
HOLE IN WEB OF (4 X 5 T-BEAM) APPROXIMATELY 3 FT FORWARD OF WEB FRAME (434)  
AT 1<sup>ST</sup> STRINGER FROM MARGIN PLATE.

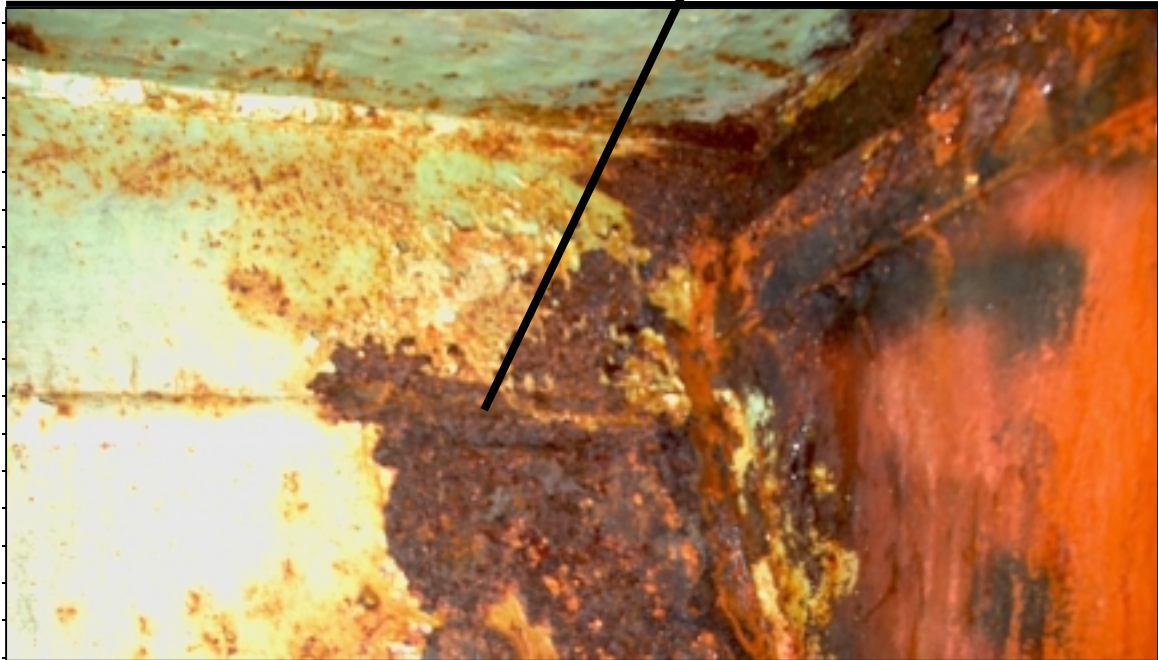
CORROSION ON SHELL AT WEB FRAME (448)
